AMMRC TR 78-14 BRITTLE MATERIALS DESIGN, HIGH TEMPERATURE GAS TURBINE

Volume 1 Ceramic Component Fabrication and Demonstration

March, 1978

Interim Report Number 12, January 1, 1977 to September 30, 1977

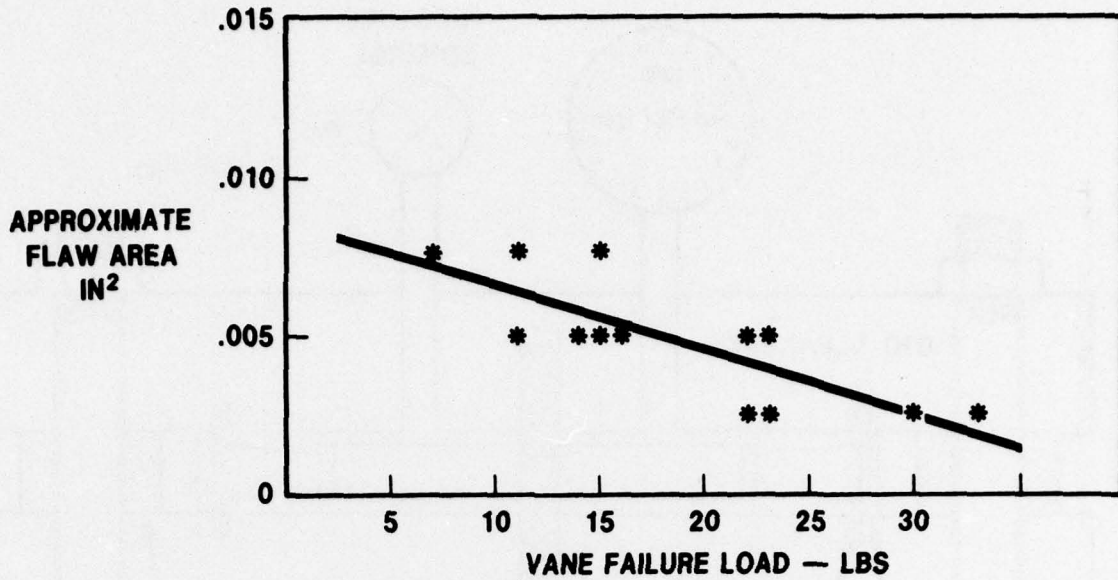
In reviewing the vane load capability (Figures 3.24 and 3.25) it was noted that a majority of the vanes (66 out of 77) successfully withstood an applied load of greater than 19 pounds. Of the 11 which did not, 7 contained the previously noted central interior flaw.

These observations indicated that an increase in the qualification load to 19 pounds could enhance the screening out of poor quality vanes without jeopardizing quality components. To verify this, 5 stator assemblies were subjected to a 19 pound/vane qualification load and subsequently 10-light tested. Vanes in two of these stator assemblies failed during the 10-light test. This result was therefore still not satisfactory and an effort continues in this area.

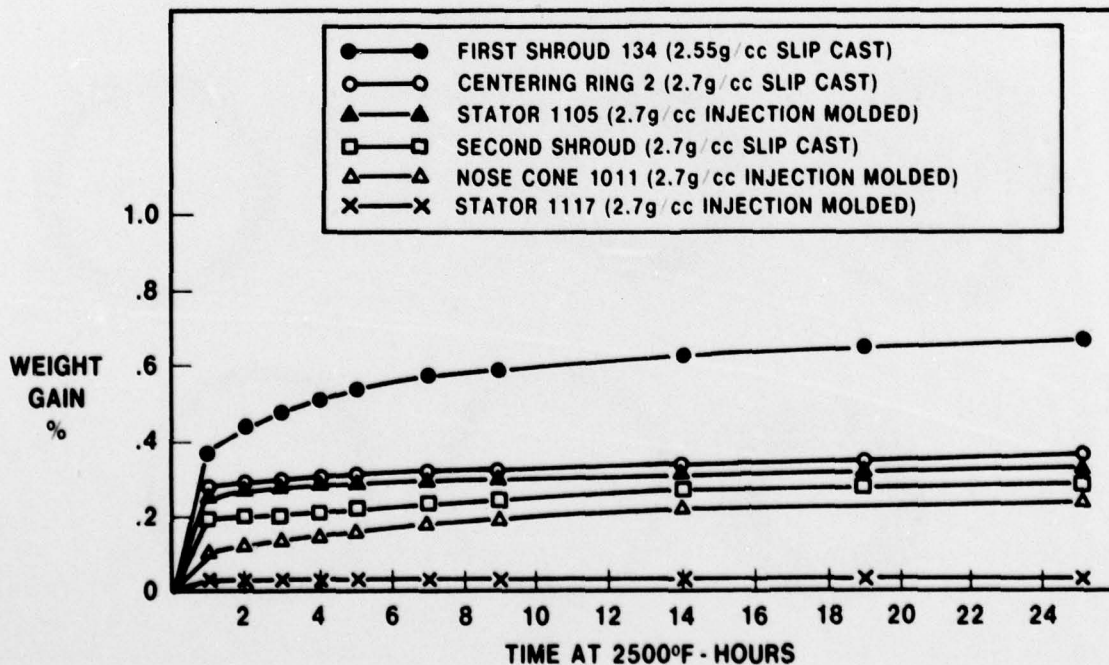
Figure 3.30 — Percent Weight Gain versus Time Data for 25 Hour, 2500°F Components

As was the case with the 175 hour, 1930°F durability components, weight gain versus time at temperature data was accumulated. Figure 3.30 documents this data for the flow path components tested for 25 hours at 2500°F. This is the initial data obtained on engine components at this temperature for extended times. The only observation to be made at this point is that weight gain rates and total percent weight gains after 25 hours are comparable to the data obtained on successful 1930°F durability tested components.
